## SIMONA® PE 100 products for a drinking water pipeline in Belgium

### The project at a glance

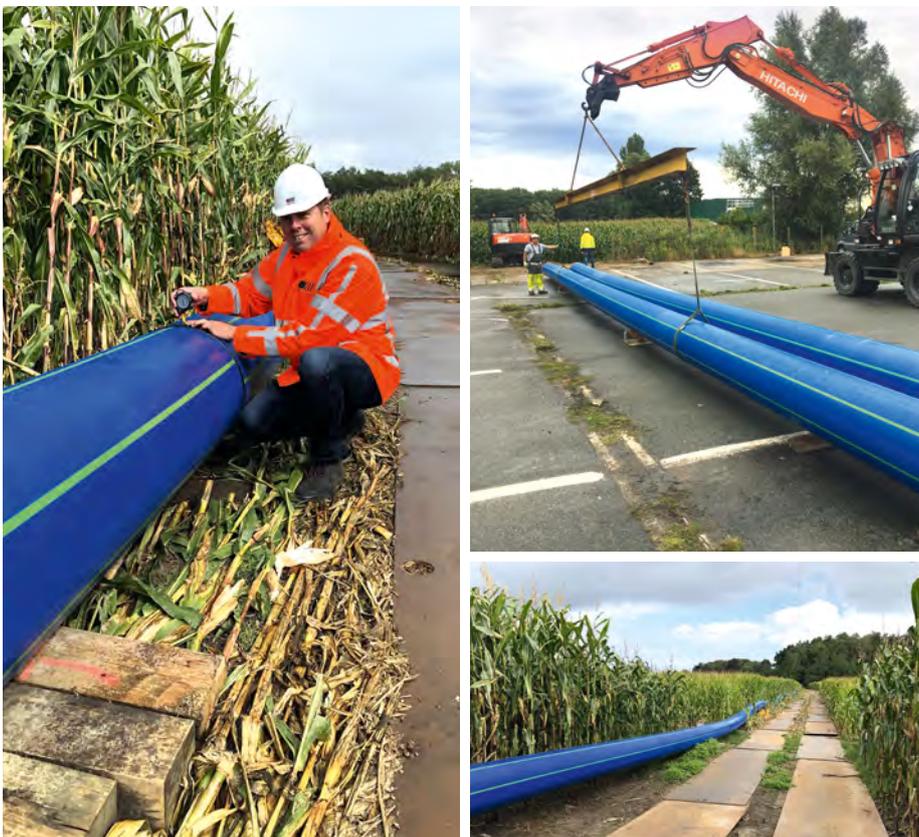
Left: Before pipe insertion, the pipes are accurately measured and checked. Top right: Transporting the 20 m long pressure pipes to the site. Bottom right: The total length renovated by horizontal directional drilling was about 740 m.

Renovation by horizontal directional drilling took place over a length of about 740 m. In another section where the pipe route was open-cut, 420 m of SIMONA® PE 100 pressure pipes were laid. For both methods of laying, the pipes used had a diameter of 500 mm in SDR 11. Even after trenchless laying, SIMONA® PE 100 SPC RC-Line pipes still possess 100 % new-pipe quality.

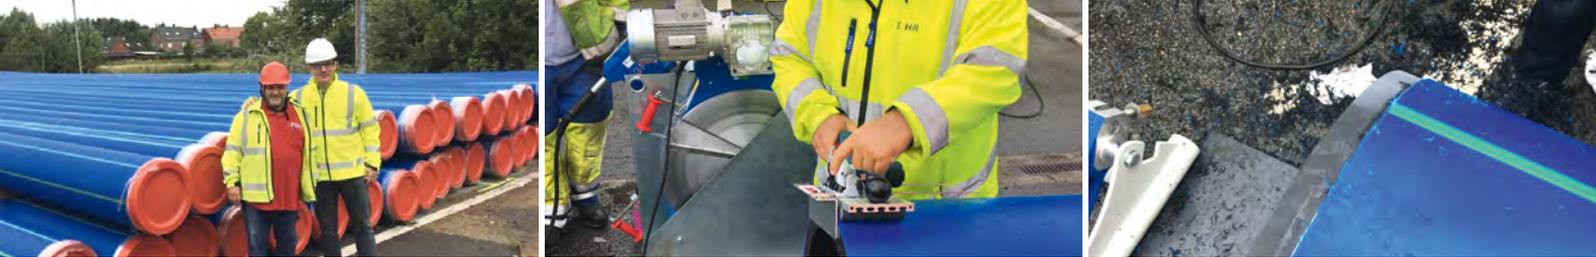
From left to right: SIMONA® PE 100 SPC RC-Line protective-jacket pipes; jacket cut-back for preparation of butt welding; pipe with jacket cut-back prepared for the welding process.

- Excellent bond strength and shear strength between the PE 100 RC inner pipe and the PP protective jacket
- High abrasion resistance of the PP Protect protective jacket
- No crack propagation from the PP protective jacket into the PE 100 RC inner pipe
- High inner pipe resistance to slow crack propagation (PE 100 RC)
- Extremely effective protection of PE 100 SPC against major physical damage such as notches, abrasion and wear
- Top-quality material ensures a high level of tensile strength for the pipe as a whole
